**NORTH SCHAUMBURG REDEVELOPMENT PLAN  
TAX INCREMENT FINANCING  
ELIGIBILITY STUDY**

**VILLAGE OF SCHAUMBURG, ILLINOIS**

**FINAL** January, 2014

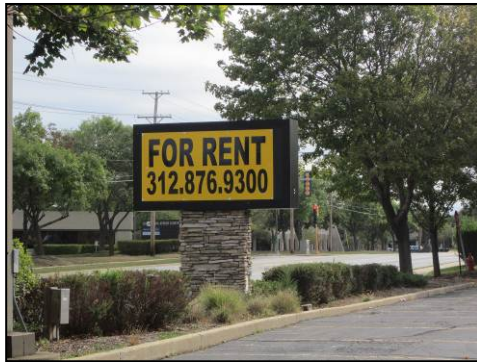
Overall, “obsolescence” is present to a meaningful extent throughout the Project Area. Obsolescence within the Project Area includes multi-family residential buildings containing obsolete

heating, ventilation, and air-conditioning (HVAC) as evidenced by window air conditioners protruding from windows, as opposed to high-efficiency HVAC systems contained in modern residential construction. Additionally, enclosed parking provided for Field Pointe of Schaumburg is constrained by limited floor-to-ceiling heights, and 6-foot-1-inch garage door heights. The International Village apartments, constructed in 1967, also lack amenities available in modern multi-family developments.

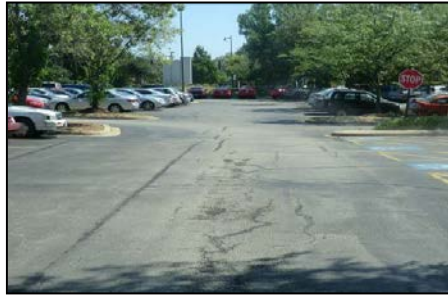
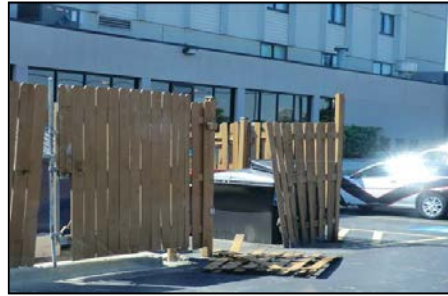
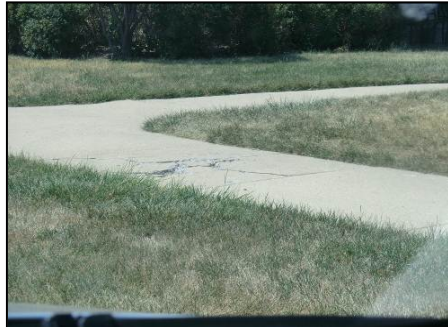
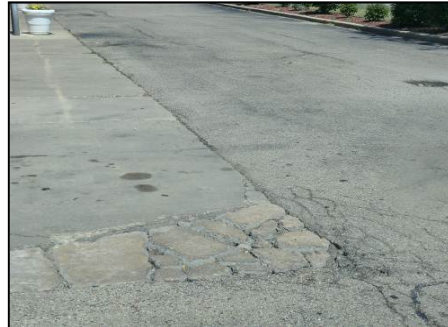
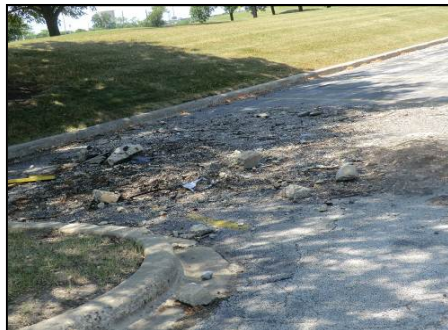
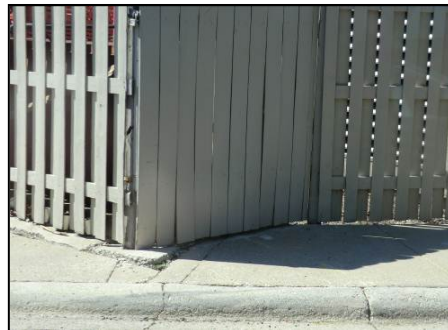
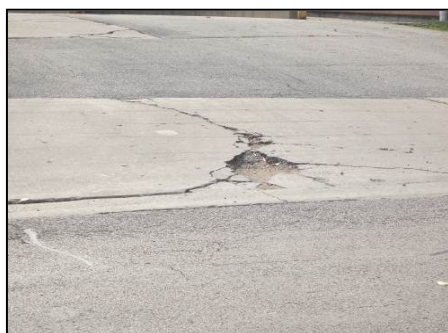
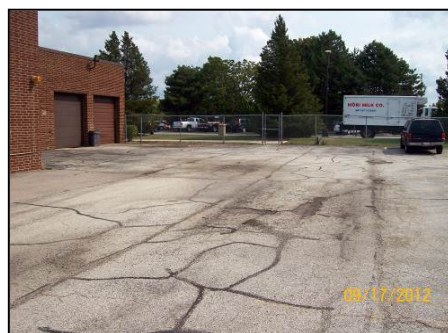
*Examples of deteriorating site improvements throughout the Project Area (streets, parking areas, sidewalks, curbs, fences, etc.)*

Various site improvements and parking lots are in poor condition throughout the Project Area, with surface parking lots containing extensive cracking, potholes and depressions, protruding weed growth, instances of crumbling curbs and gutters, cracks in sidewalks, collapsing fences, and failing retaining walls. **TABLE 2, Summary of Building Conditions**, tabulates primary building deterioration by extent and location. Overall, deterioration of site improvements is present in all twelve (12) sub-areas within the Project Area, while minor deterioration of buildings is present in eight (8) out of twelve (12) sub-areas. Major deterioration is present in only one (1) out of twelve (12) sub-areas.

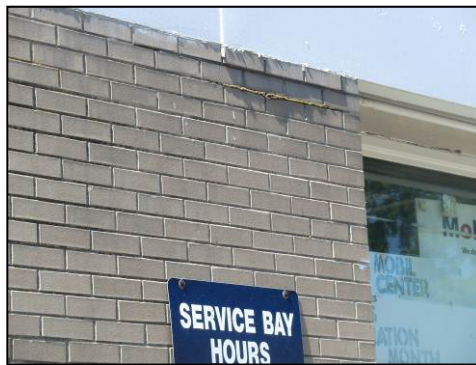
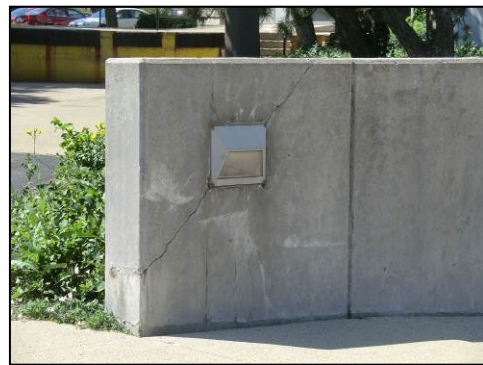
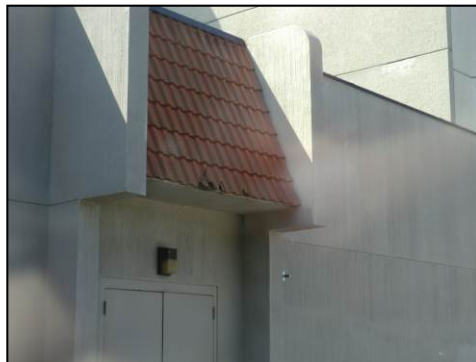
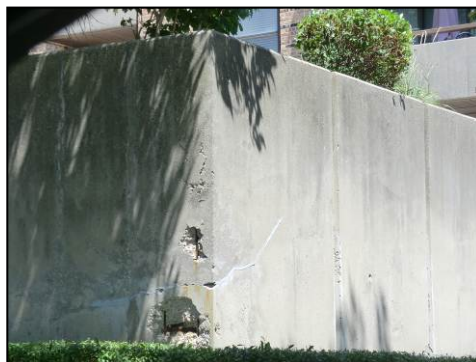
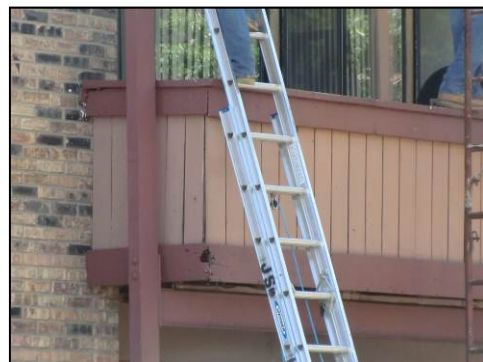
*Examples of deteriorating building improvements throughout the Project Area (foundation cracks, tuck pointing, decks, roofs, etc.)*

Of the 156 structures within the Project Area, 91 exhibit some signs of deterioration (or 58%). Overall, deterioration of buildings and site improvements is present to a meaningful extent throughout the entire Project Area.

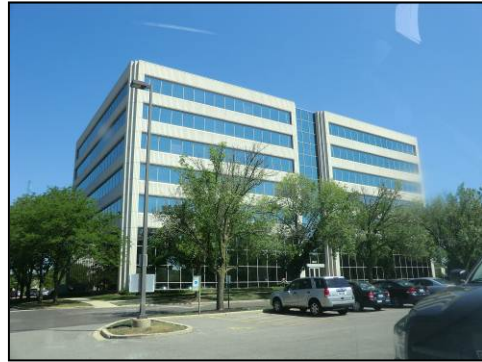
The factor of excessive vacancies is present to a meaningful extent in office buildings throughout the Project Area, throughout the Motorola campus and Tollway Industrial Park, and in residential buildings located in Sub-Areas 2 and 4.

In addition, currently thirteen (13) of fifteen (15) office buildings (87%) in the Project Area contain excessive vacancy rates. During the past years, from 2009 to the first quarter of 2013, the combined vacancy rates for the total leasable office space throughout the Project Area exceeded 40%. **TABLE 3, Office Building Vacancy Rates: 2009 – 2013,** lists annual office vacancy rates for the past four (4) years.

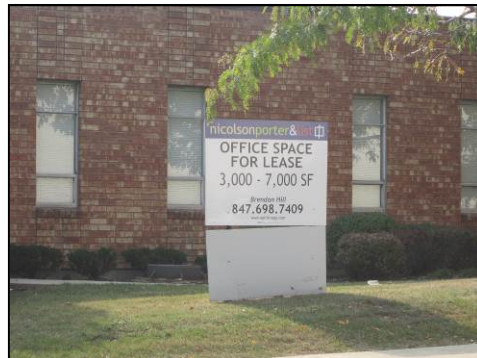
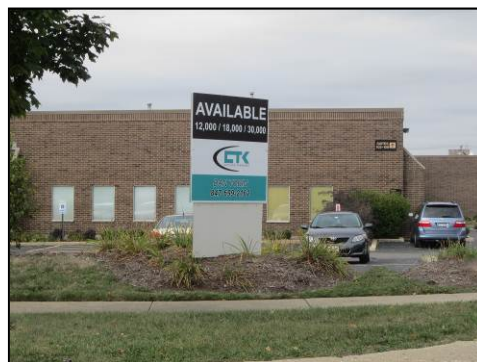
Vacancies of the four multiple-family developments range from 4% to approximately 20%. In addition, the Tollway Industrial Park contains scattered vacancies (6 of 37 buildings, or 16%) throughout the development, including completely vacant buildings as well as multi-tenant buildings with partial vacancy.
